EG&G ROCKY FLATS
ENVIRONMENTAL MANAGEMENT DEPARTMENT
ASSESSMENT OF KNOWN, SUSPECT, AND POTENTIAL
ENVIRONMENTAL RELEASES OF
POLYCHLORINATED BIPHENYLS (PCBs)

PRELIMINARY ASSESSMENT/SITE DESCRIPTION

October 1991

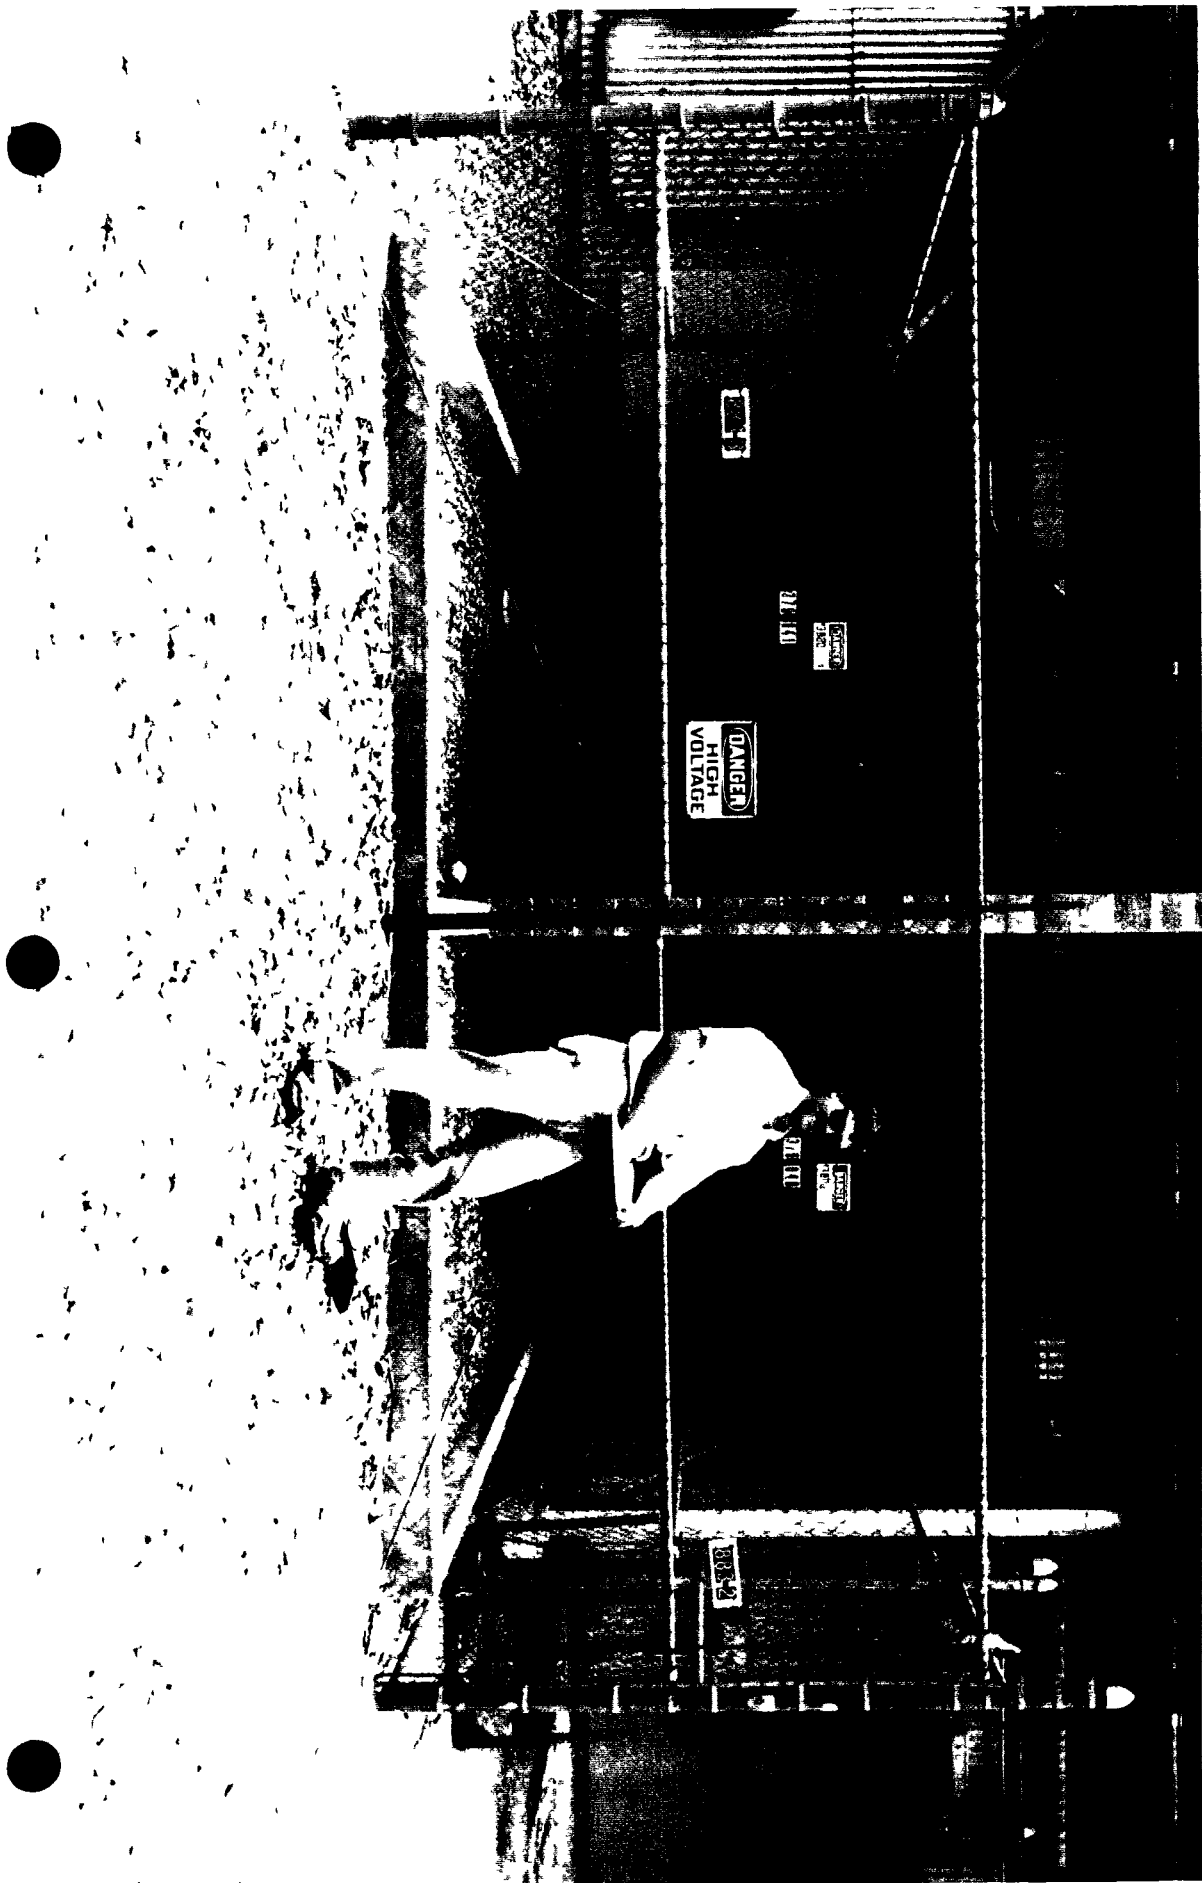
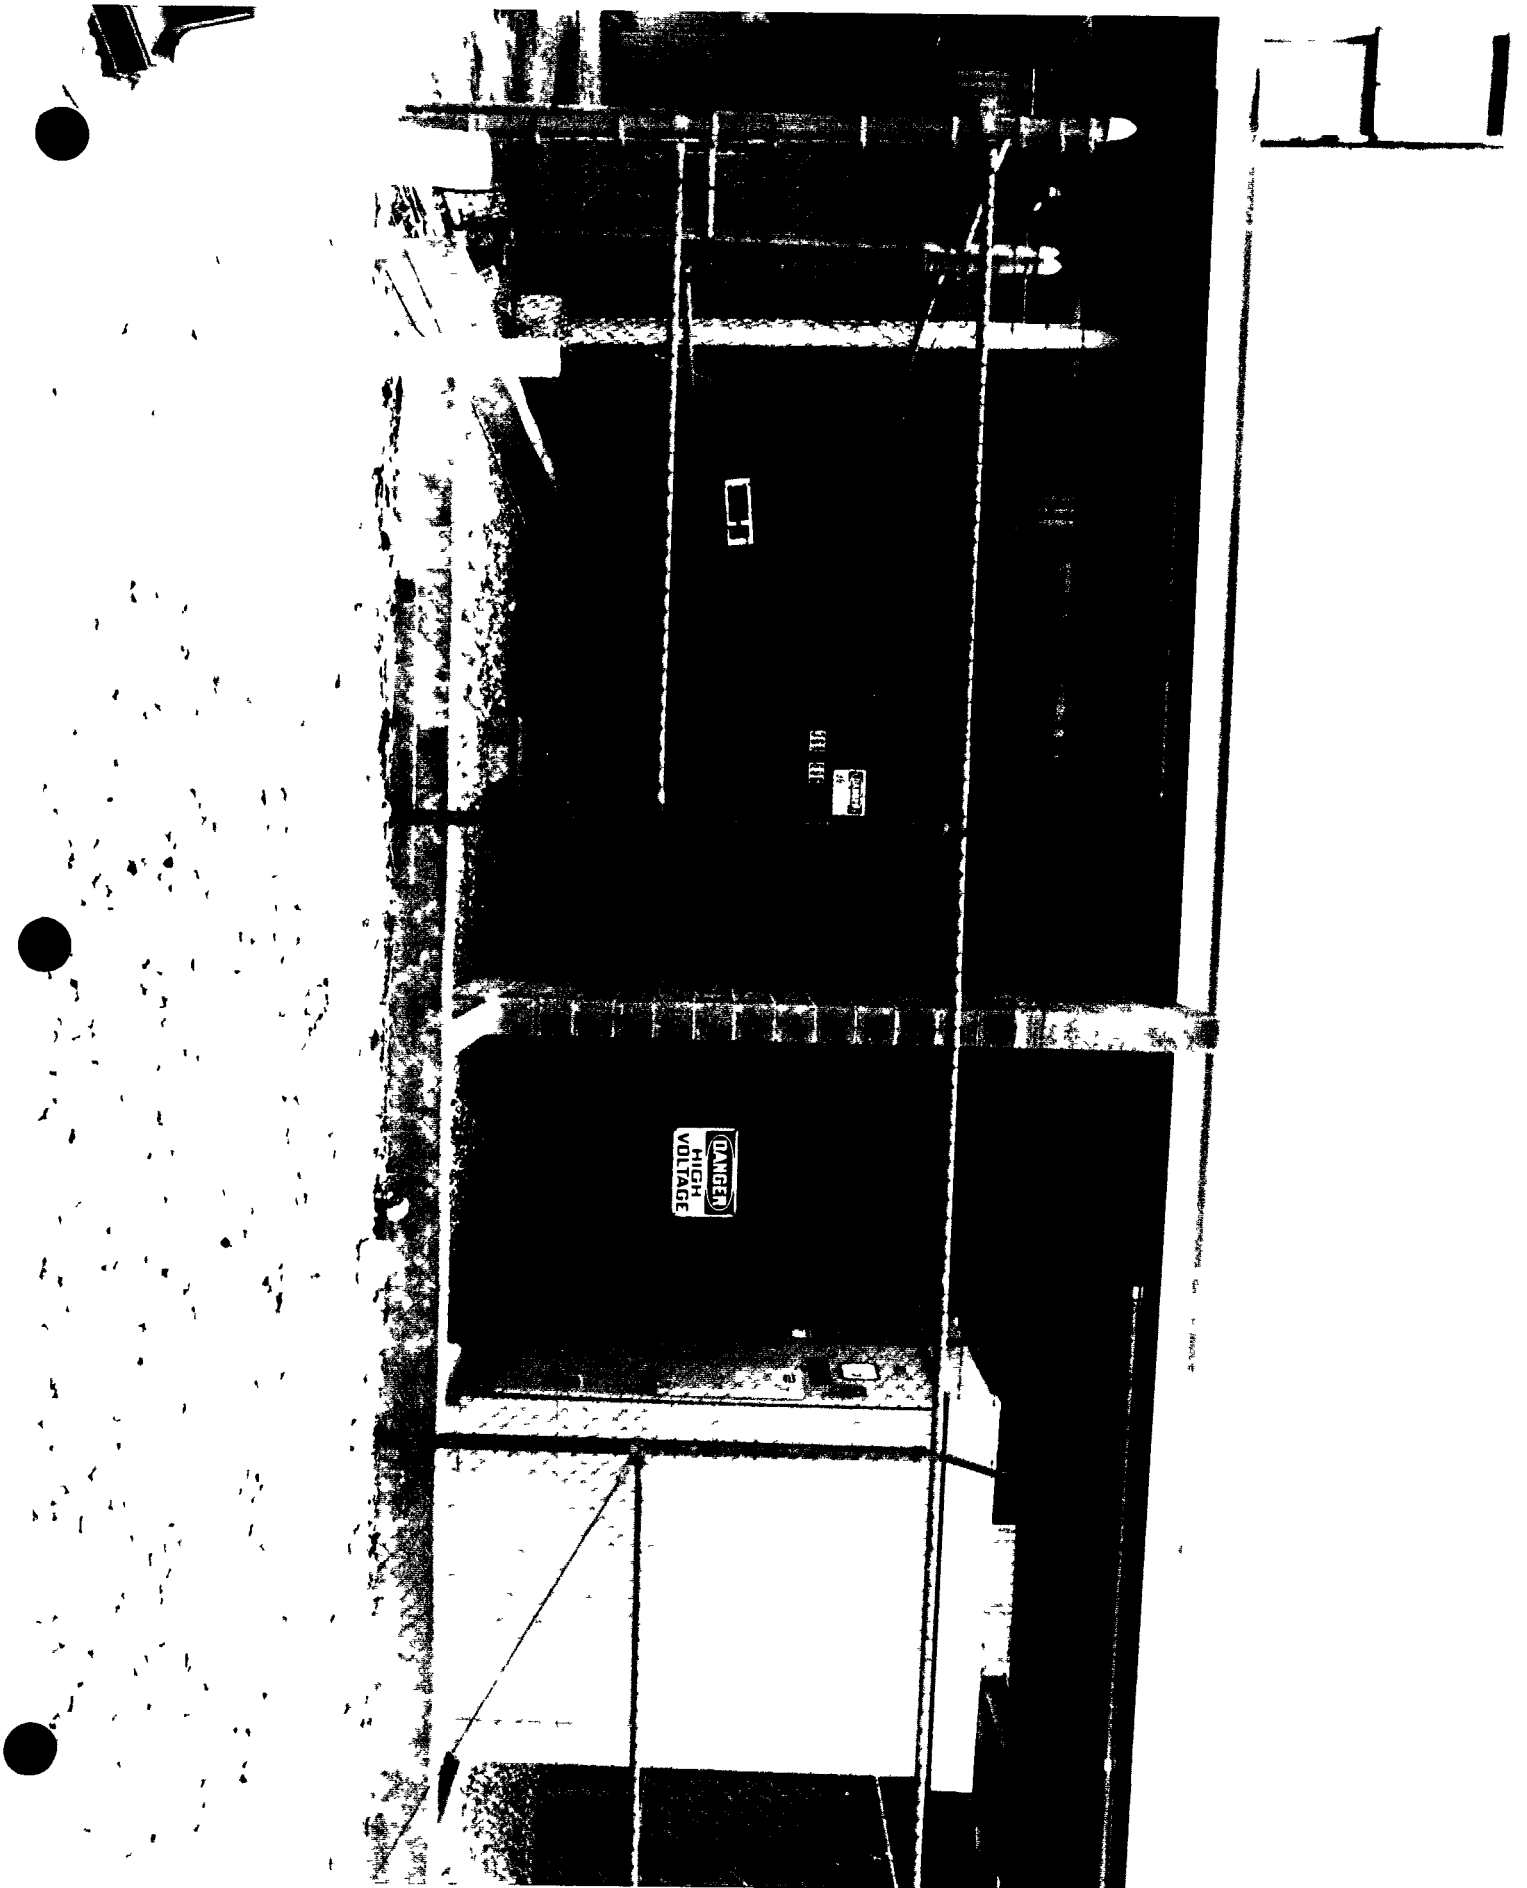
SITE #15 - Building 883 Drum Storage Area

This site is located within the 800 complex building area (Photo #15A & 15B) There are three transformers and one switch gear apparatus at this site All of the transformers and the gear apparatus may have leaked oil containing PCBs prior to the 1987 retro-fill operation according to an interview with Utilities personnel One of the three transformers shows evidence of leaking as indicated by visible oil stains at the valve All transformers and the switch gear are currently active The area is located 100 feet south of Building 889, and within IHSS 180 (Building 883 Drum Storage Area) The area is bermed and rock and gravel are placed as fill inside and outside of the berms There are no drains in the vicinity of the site

Site 15 is prioritized as a Category II

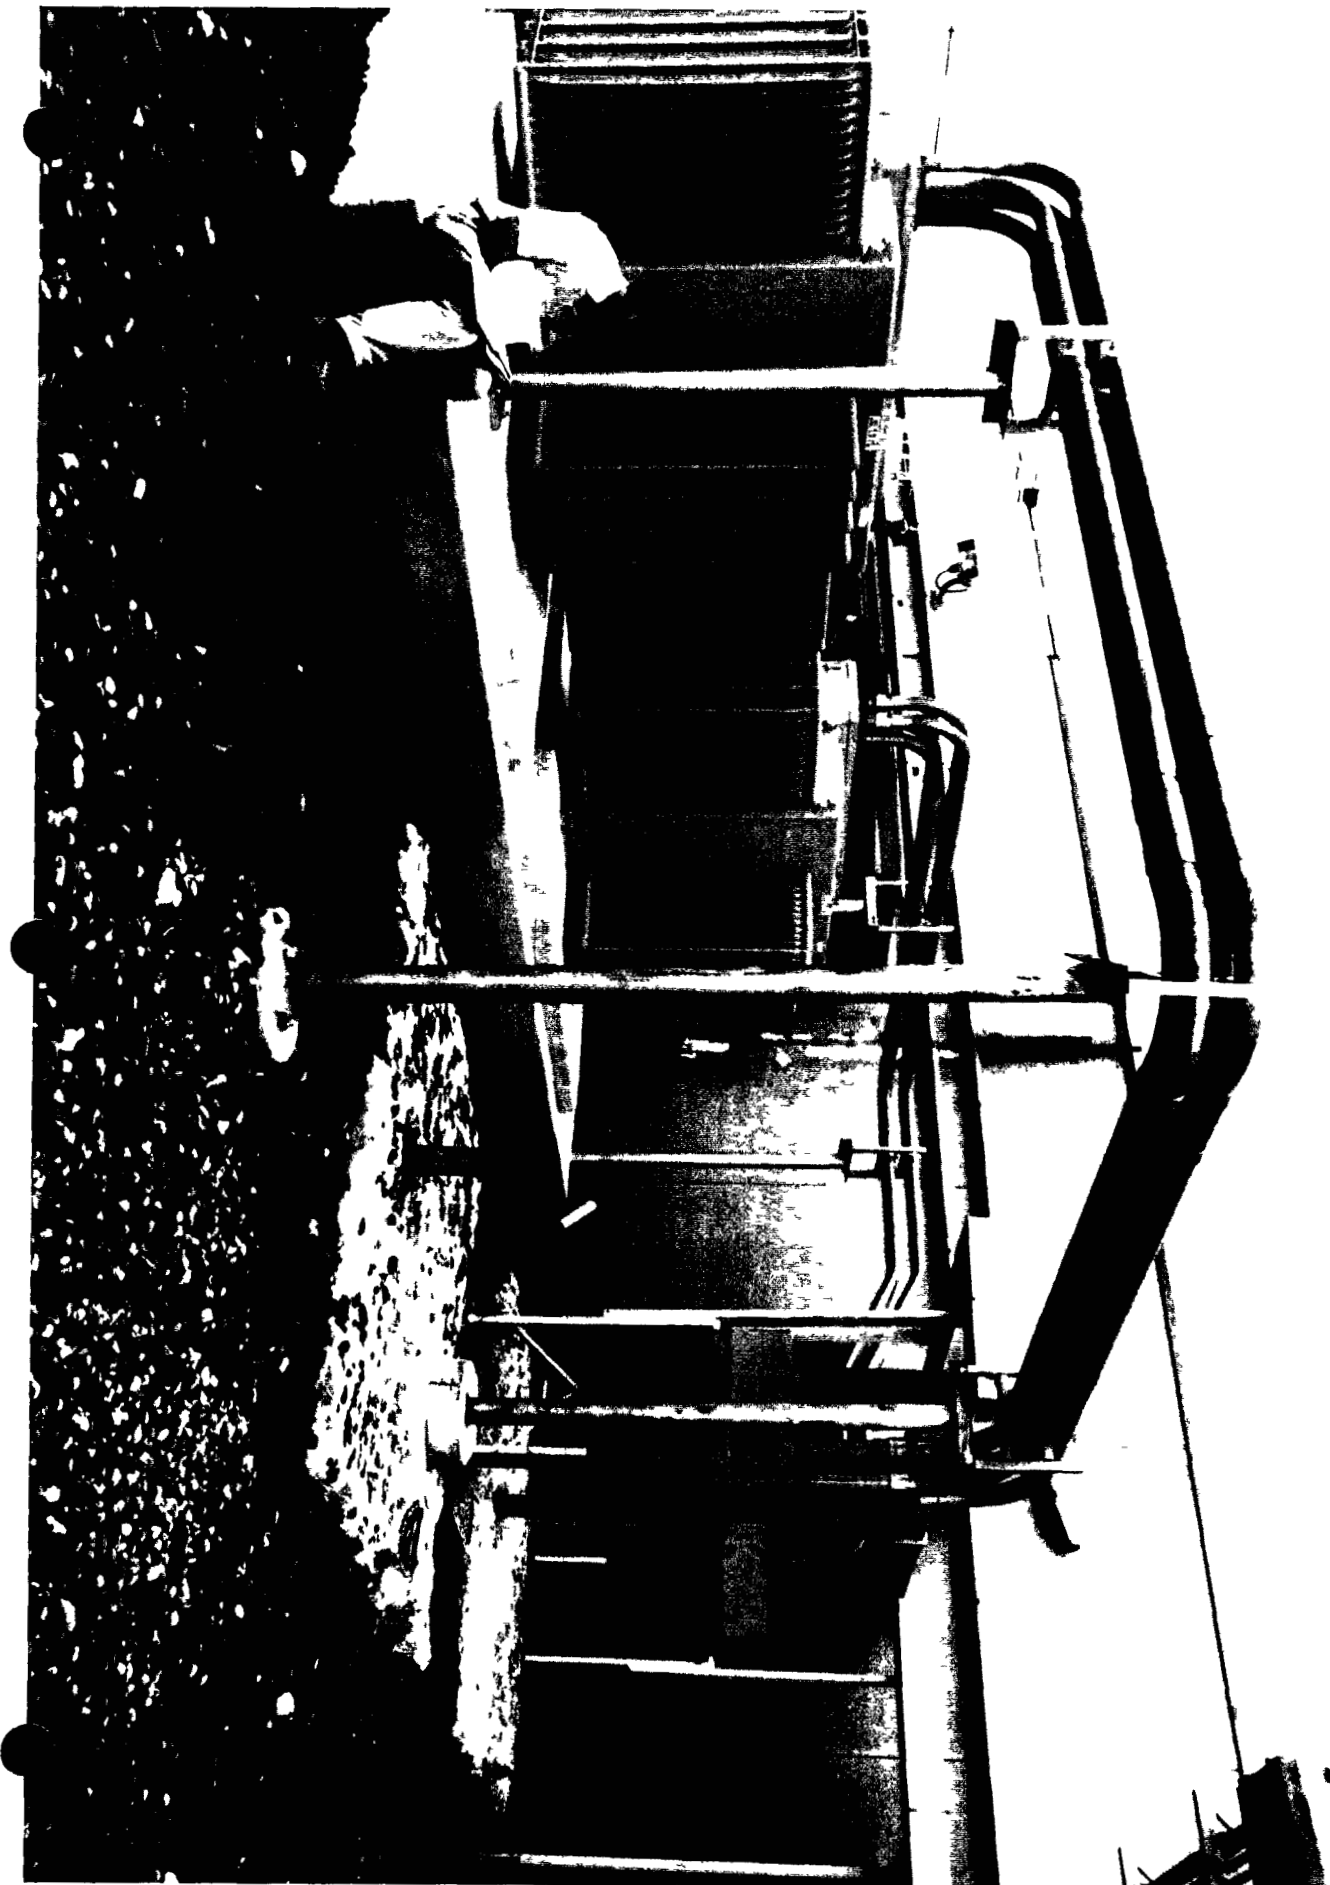
SITE #16 - North of Building 886

This site consists of two previous transformer concrete pads which have been partially removed (Photo # 16). The disposition, and consequently fate of constituents is not known at this time relative to the concrete material. An effort is being pursued to locate this information. Both of the transformers that were located on these pads (865-1, 865-2) have leaked in the past according to an interview with Utilities personnel. The transformers were removed from the pads, retro-filled, and placed on new pads several feet to the north in 1987. The site is located within the 800 area, 25 feet north of Building 886 and 30 feet west of Building 865; IHSS 179 (Building 865 Drum Storage Area) is located 30 feet east of the sampling area. The new site has berms surrounding the transformer area. It cannot be determined visually whether the old system had berms around it. There are no drains in the area. The site has rock fill surrounding the transformer.

Site #16 is prioritized as a Category II

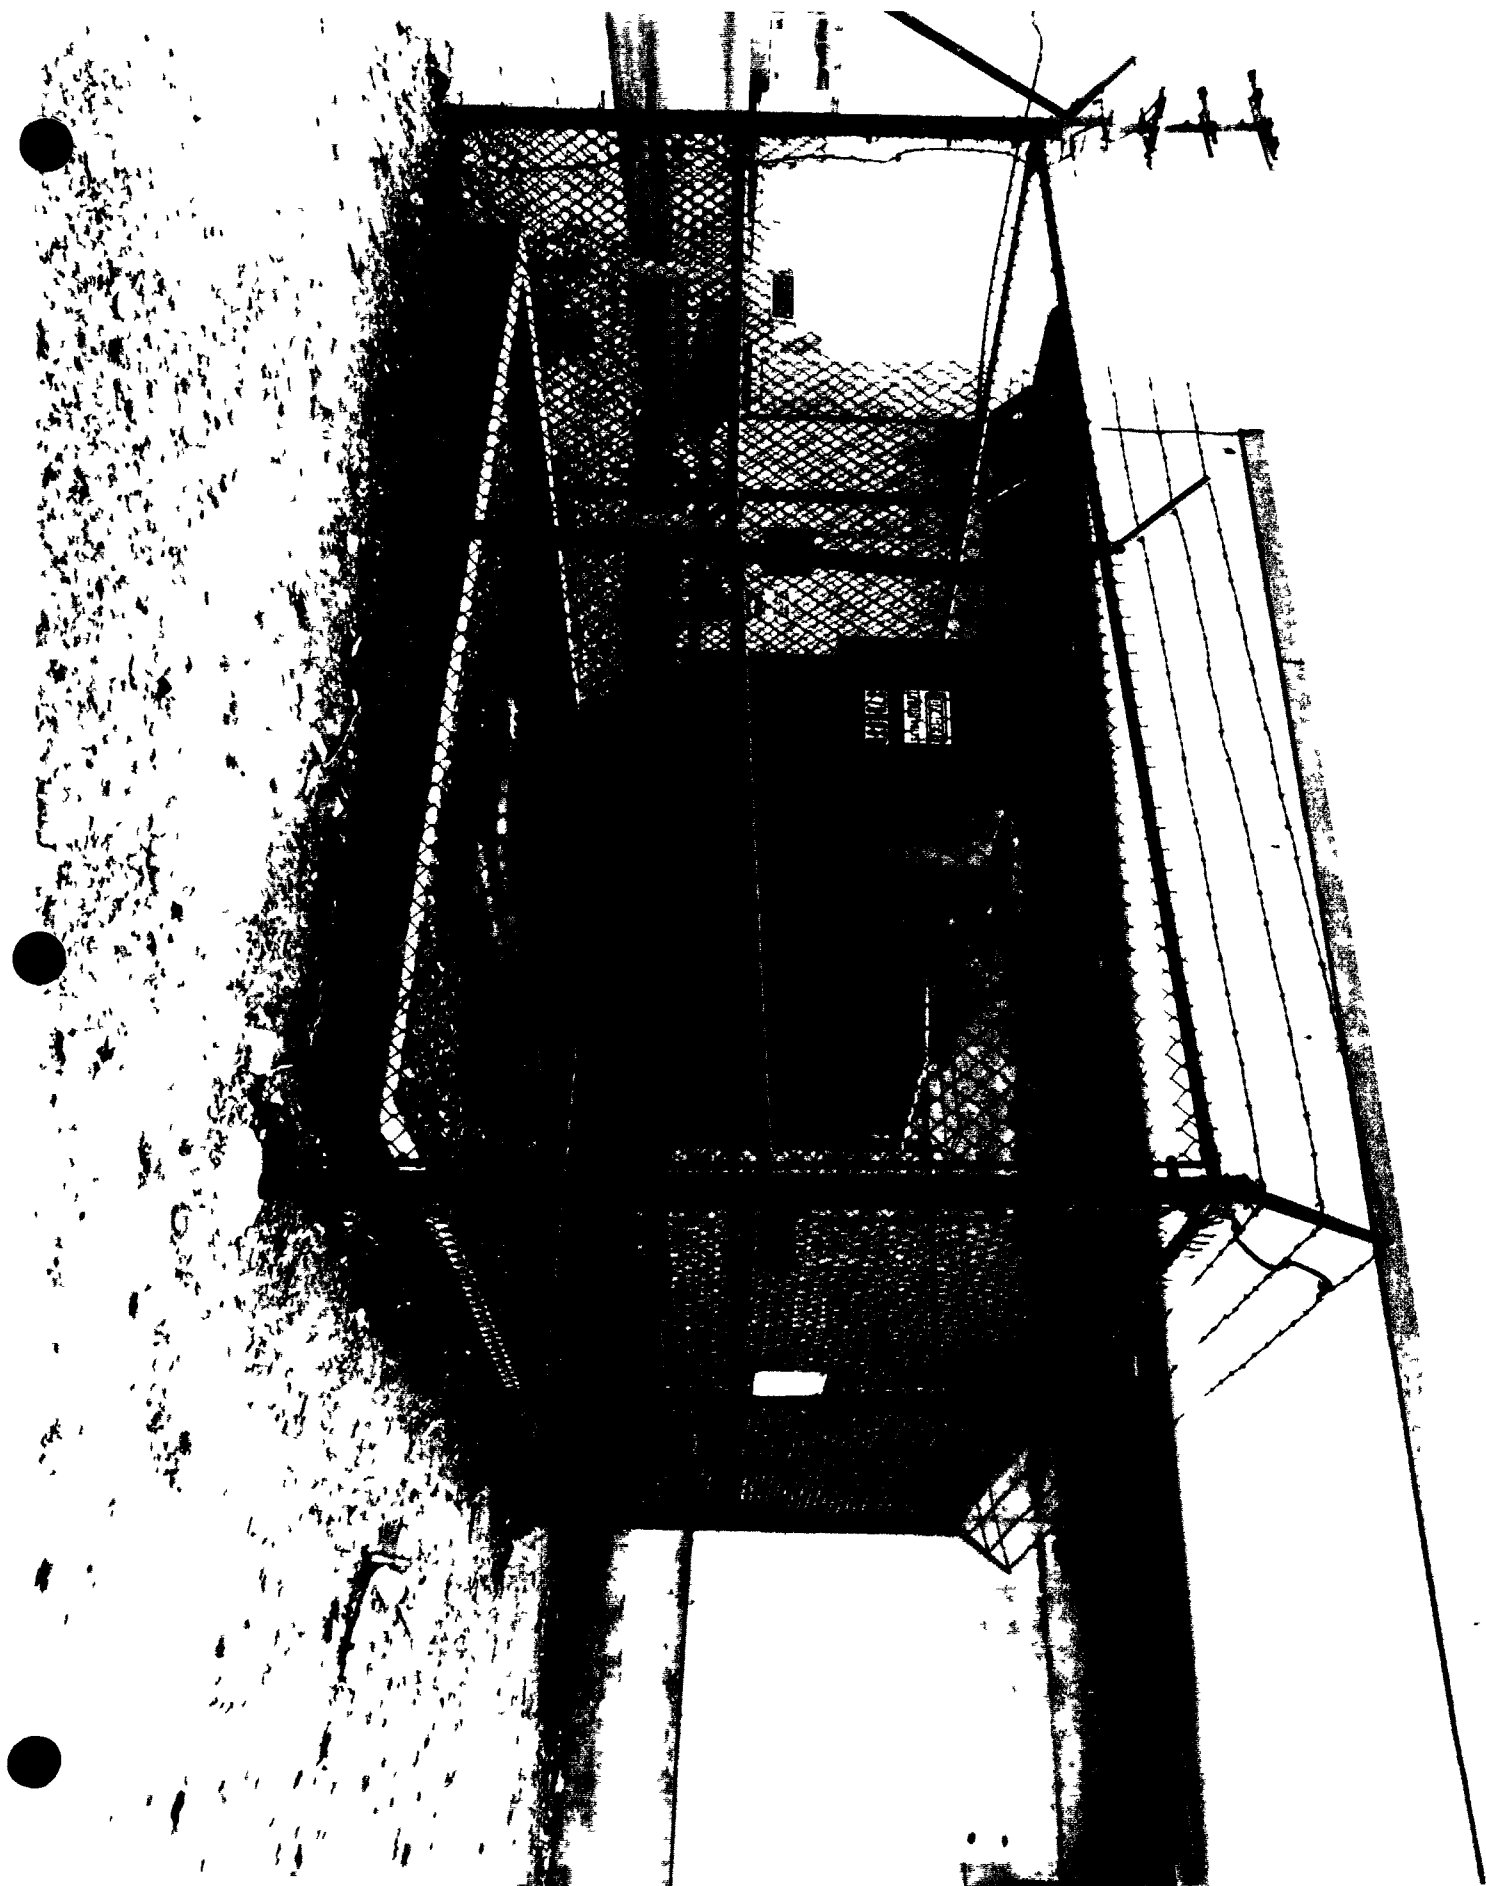
SITE #18 - Building 881 Drum Storage Area

Transformer 881-4 located at this site is believed to have leaked oil containing PCBs prior to being retro-filled in 1987 according to an interview with personnel from EG&G Utilities. The transformer is currently active and shows no indication of leaks. The transformer is located within the 800 area, adjacent to the north face wall of Building 881 (Photo #18). There is gravel fill inside the berm with undisturbed soil outside. It is not known if there is a concrete floor under the gravel fill. There are no drains in the vicinity of the site. This site is located within IHSS 178 (Building 881 Drum Storage Area).

Site #18 is prioritized as a Category II.

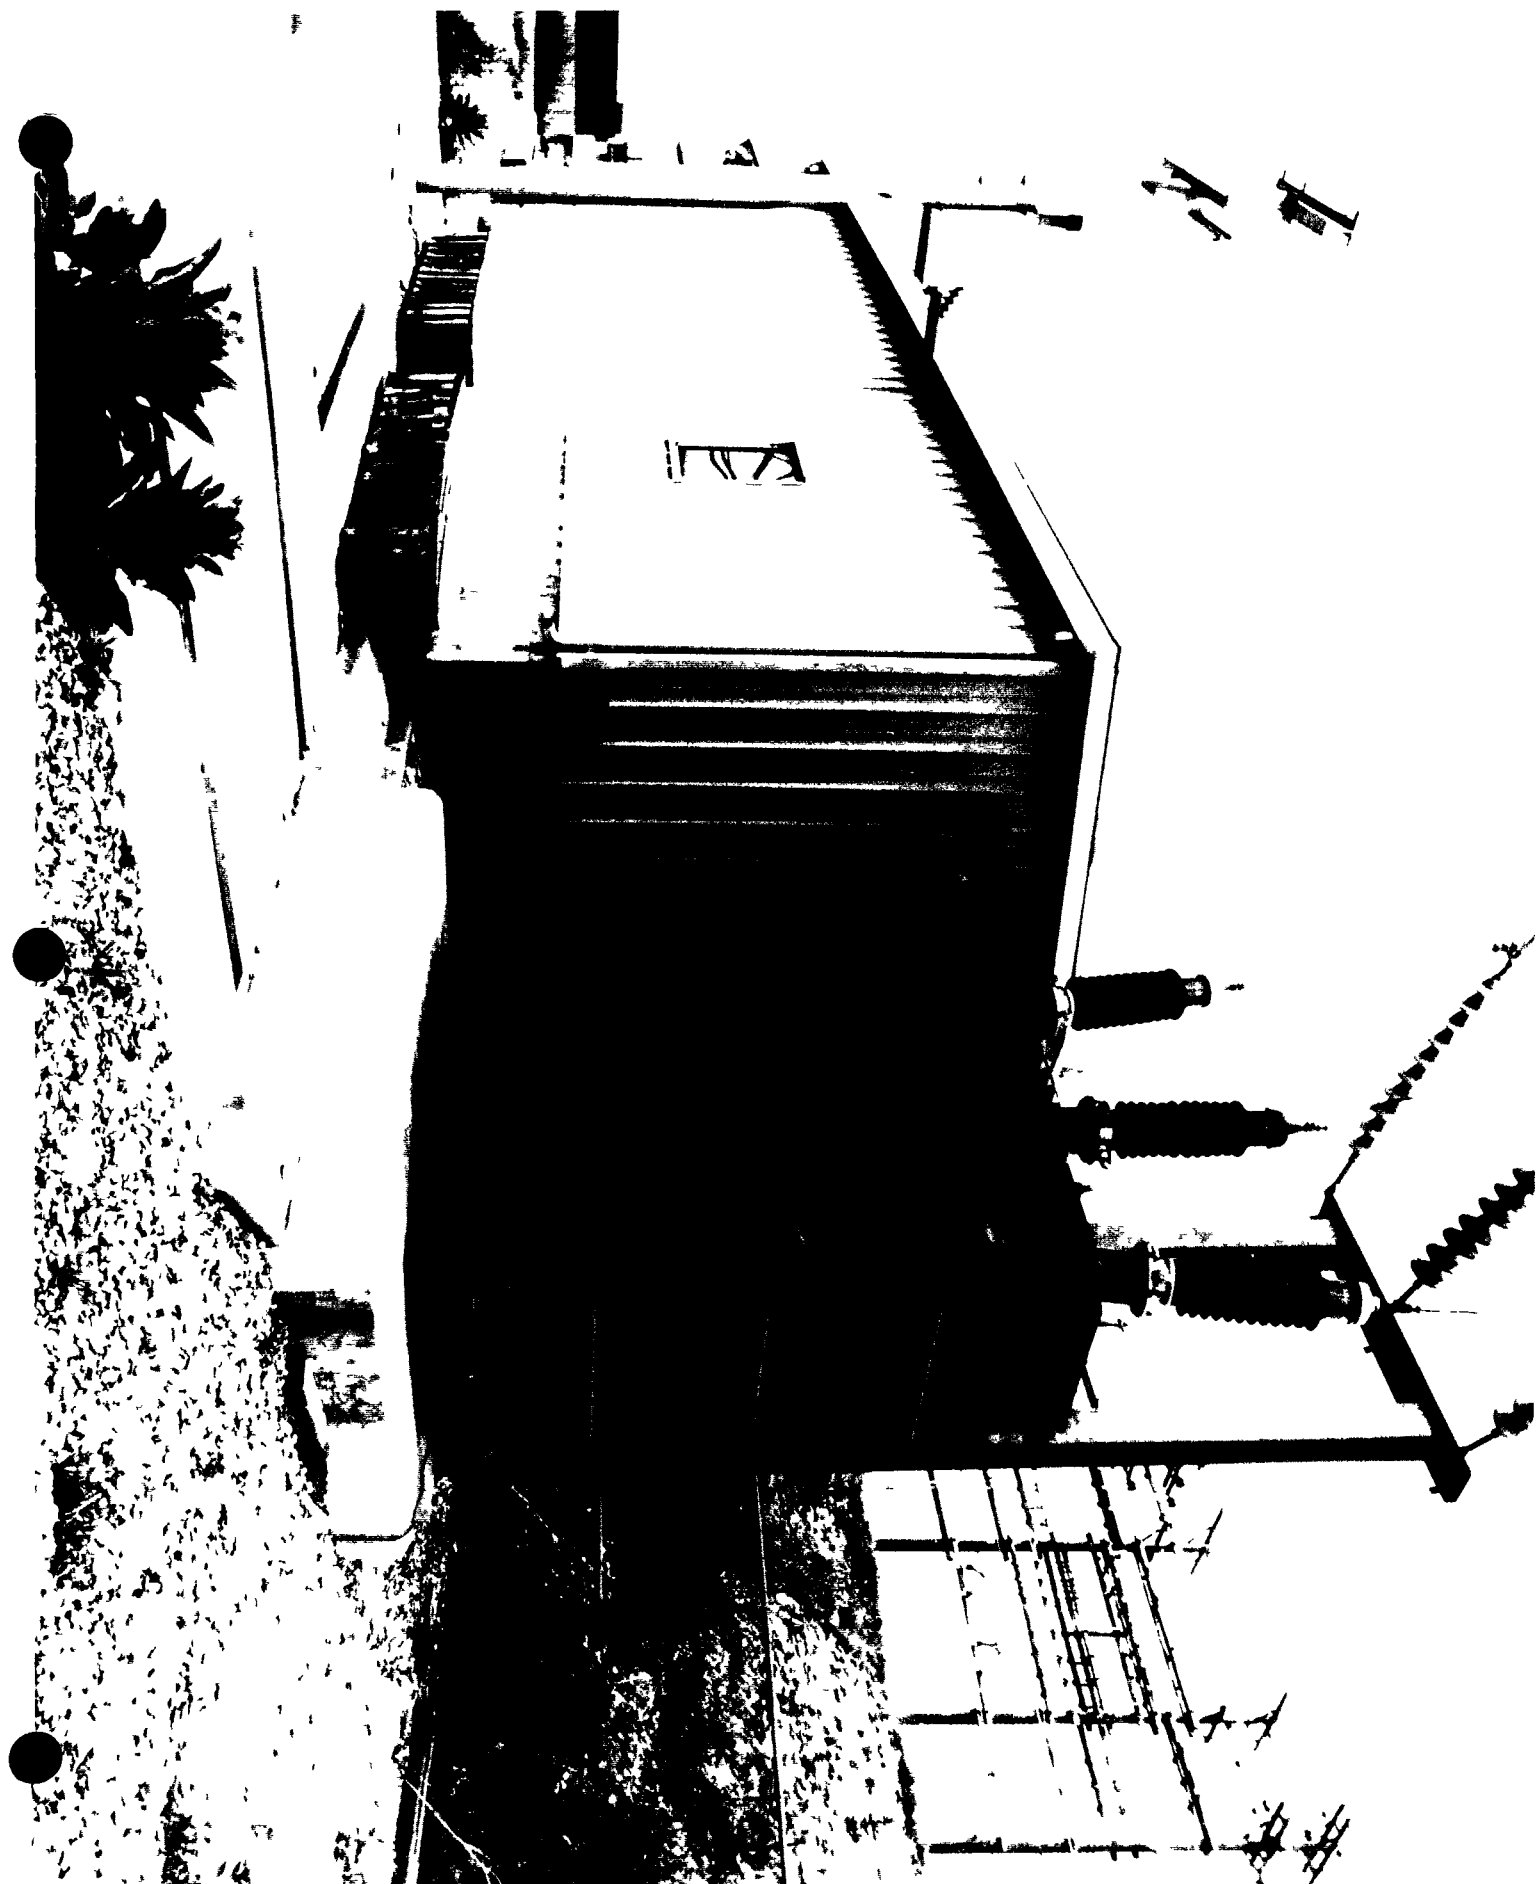
SITE #20 - South of Substation 515-516

Transformer 516 located at this site (Photo #20) shows no evidence of leaking, and it is not known whether the transformer has leaked in the past. The transformer was retro-filled in 1987.

Transformer 516 is situated on a concrete pad and is active. There is no berm at this site. Gravel fill has been placed around the pad area. The transformer is located on the south side of substation 515-516 within the PA. IHSS 117 1 is located approximately 400 feet to the southwest.

Site #20 is prioritized as a Category III.

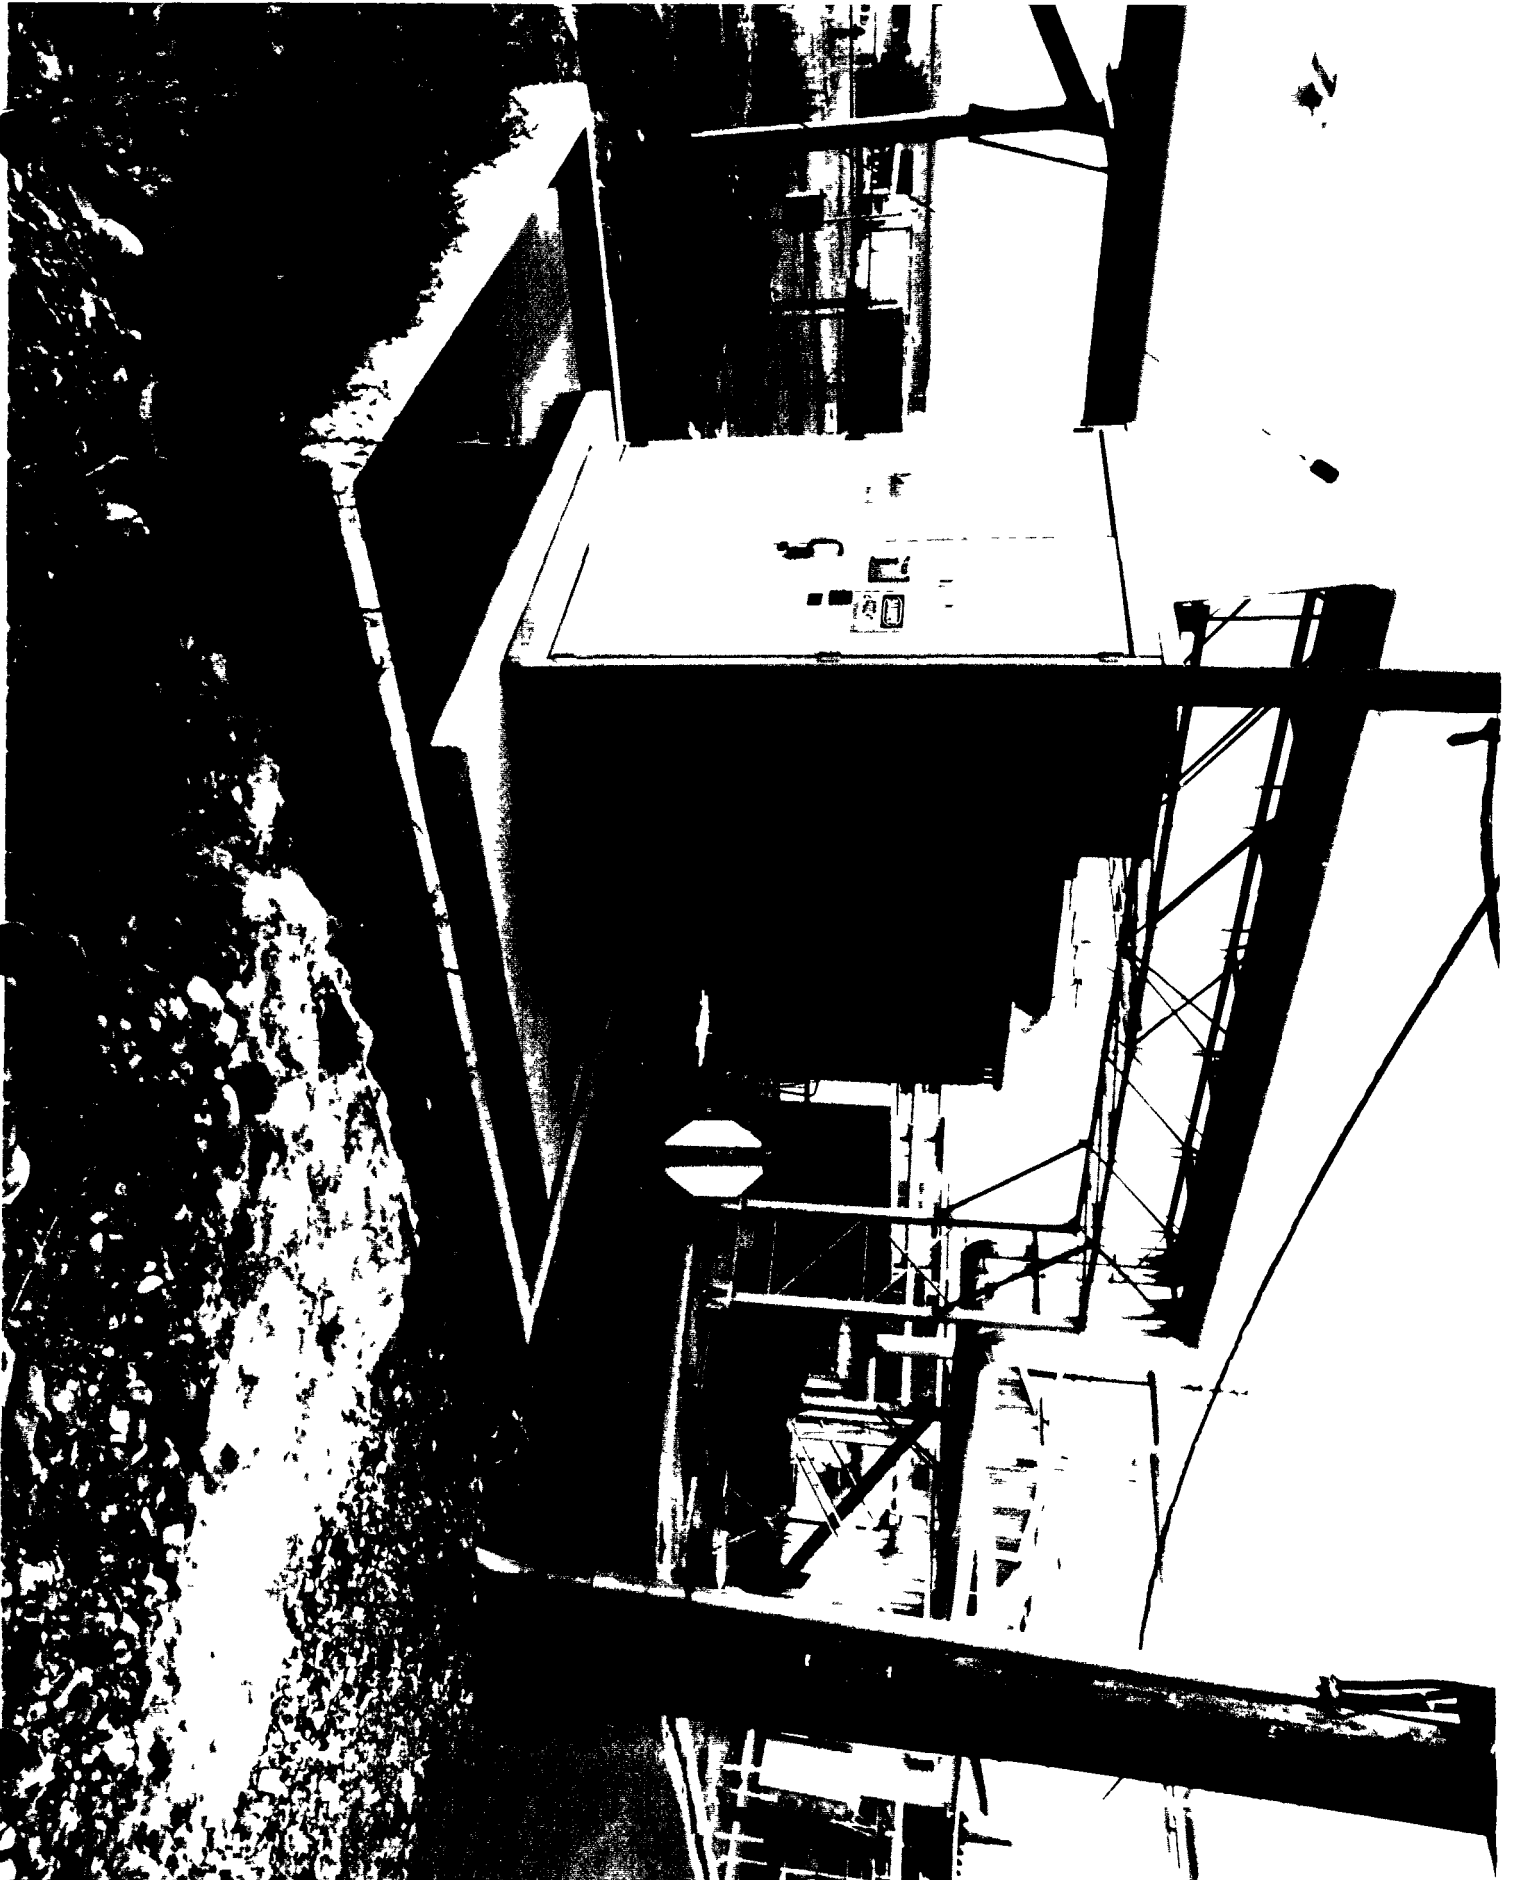
SITE #21 - Northwest corner of Building 776

This site consists of a previously utilized transformer pad which is located several feet south of the present transformer location. The transformer that was located on this pad (Transformer 776-4) is suspected to have leaked (Photo #21) according to conversations with personnel from EG&G Utilities. It is not known if the old pad had a berm around it. The old pad appears to have had some fill recently placed around it. The pad is located on an incline with drainage toward an access road fifteen feet to the east. No drains were located near the site. The transformer was removed for retro-filling and relocation several feet north in 1987. The pad has been partially removed to a depth of 4". The disposition of the concrete material is not known at this time, and consequently, the fate of constituents from the concrete material. An effort is being pursued to locate this information. The pad is located 70 feet west of the northwest corner of Building 776 and 30 feet west of IHSS 150 2.

Site #21 is prioritized as a Category II.

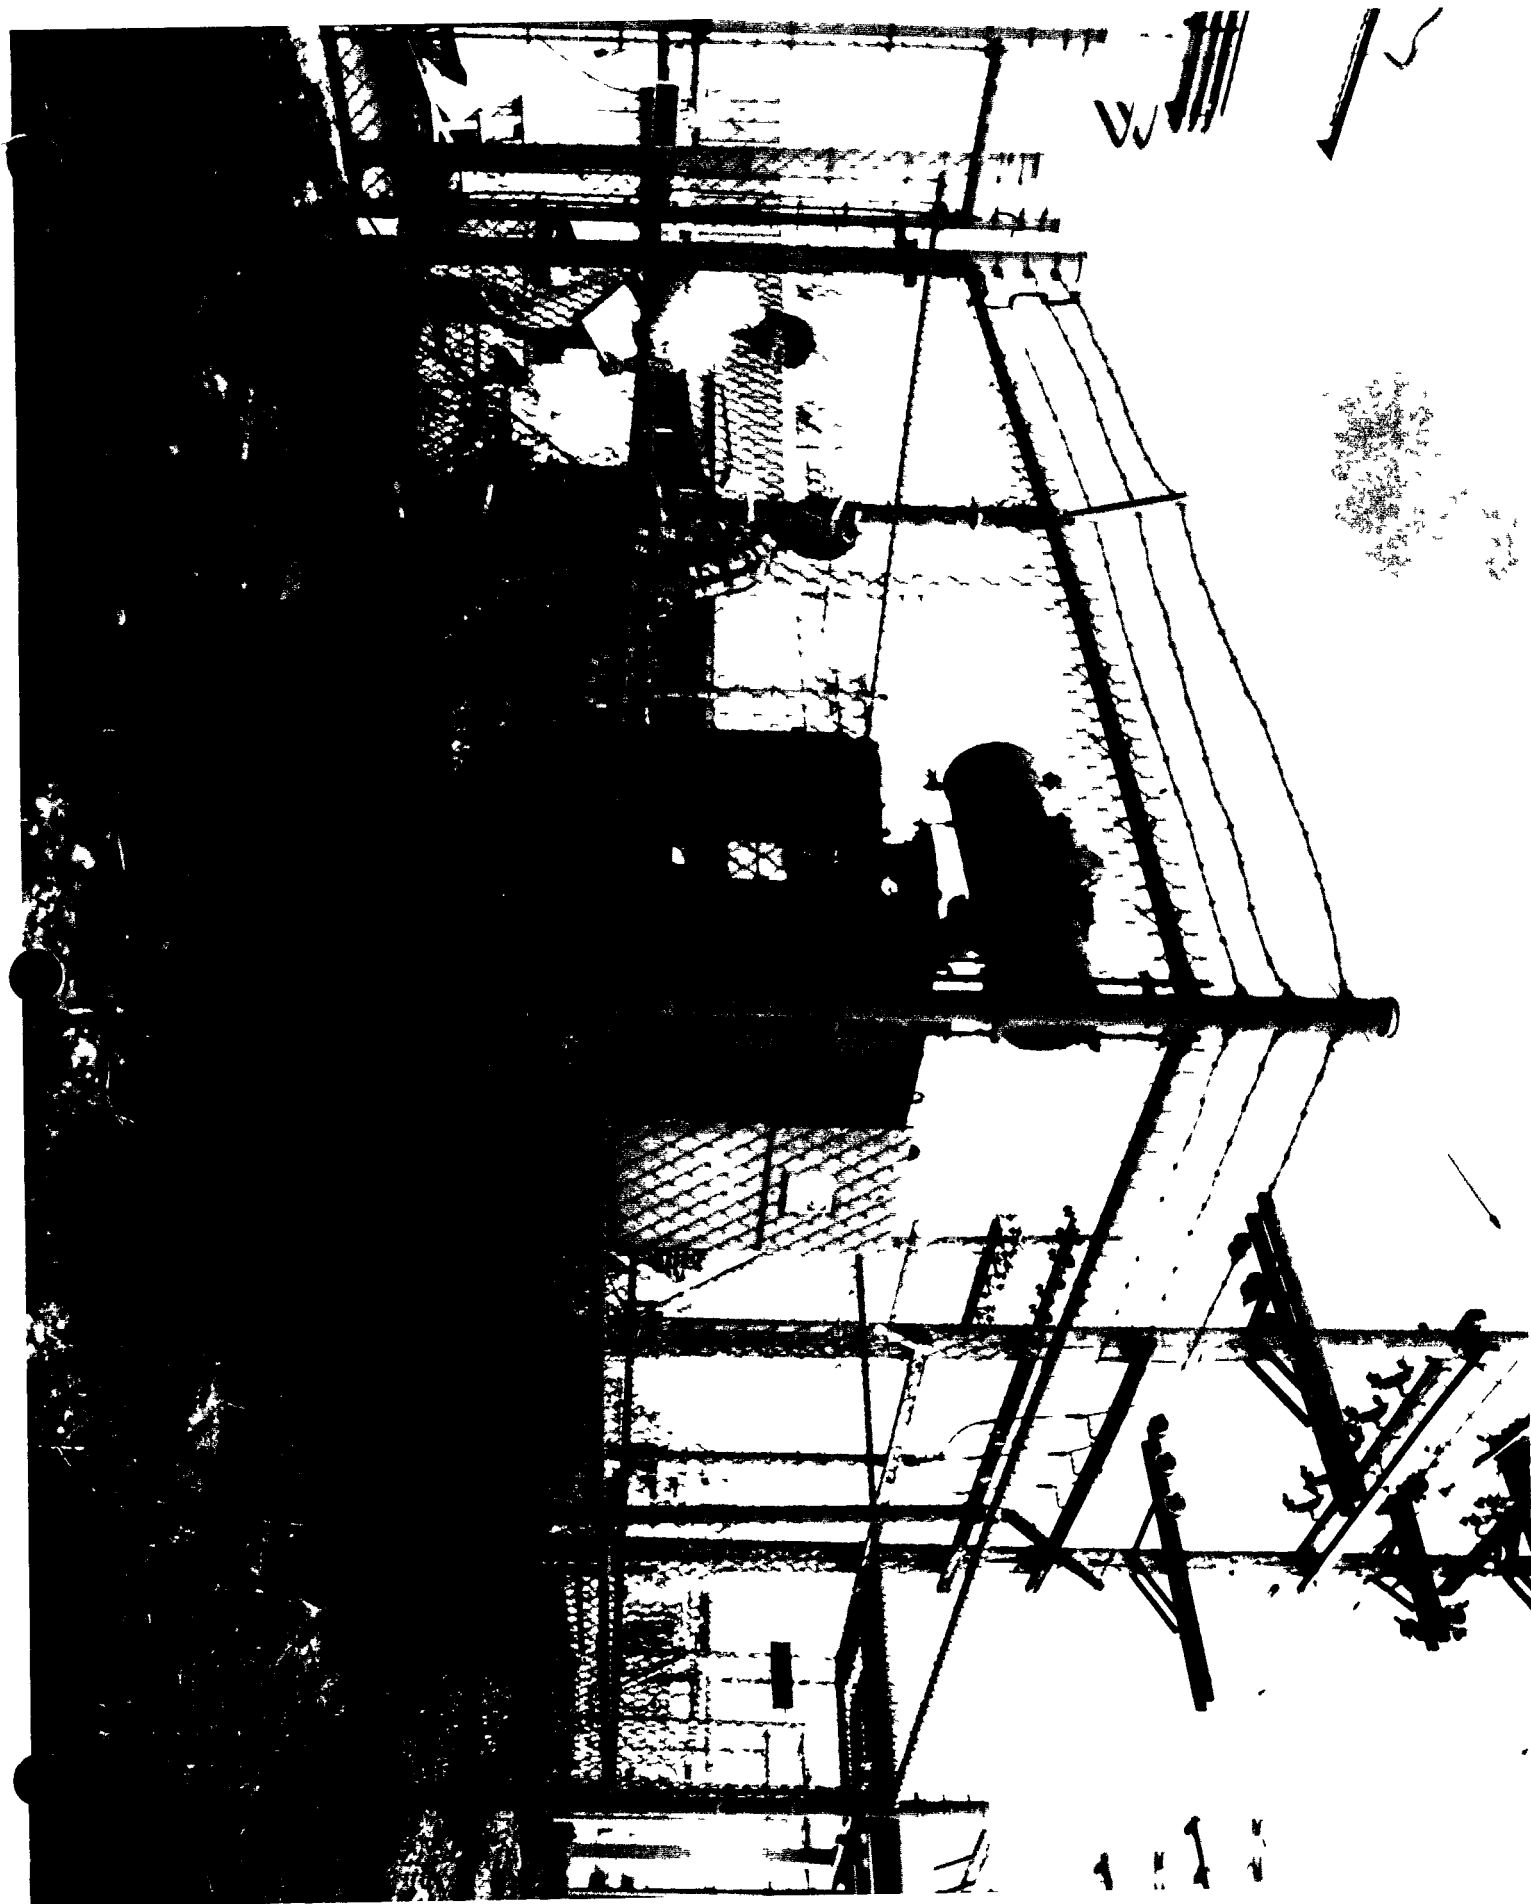
SITE #22 - Southwest corner of Building 776

The transformer located at this site (Transformer 370-055) may have experienced a leaking valve prior to being retro-filled in 1987 according to an interview with personnel from Utilities. The transformer is currently active and shows no evidence of leakage (Photo #22). The transformer is situated on a concrete pad with a berm surrounding it. The site is located on an incline. There were no drains located in the vicinity. The site is located 70 feet west of the southwest corner of Building 776, 30 feet west of IHSS 150 2, and 35 feet west of IHSS 162.

Site #22 is prioritized as a Category II
